REHABILITATION WORKS AT HALL 1 READING ROOM

BY
UNIVERSITY OF BENIN ALUMNI ASSOCIATION
(NORTH AMERICA CHAPTER - UBAANA)

This document presents a report on the rehabilitation works carried out by the North America Chapter of the University of Benin Alumni Association (UBAANA) in Hall 1 Reading Room at the Ugbowo Campus of University of Benin. The project was executed using the direct labour approach.

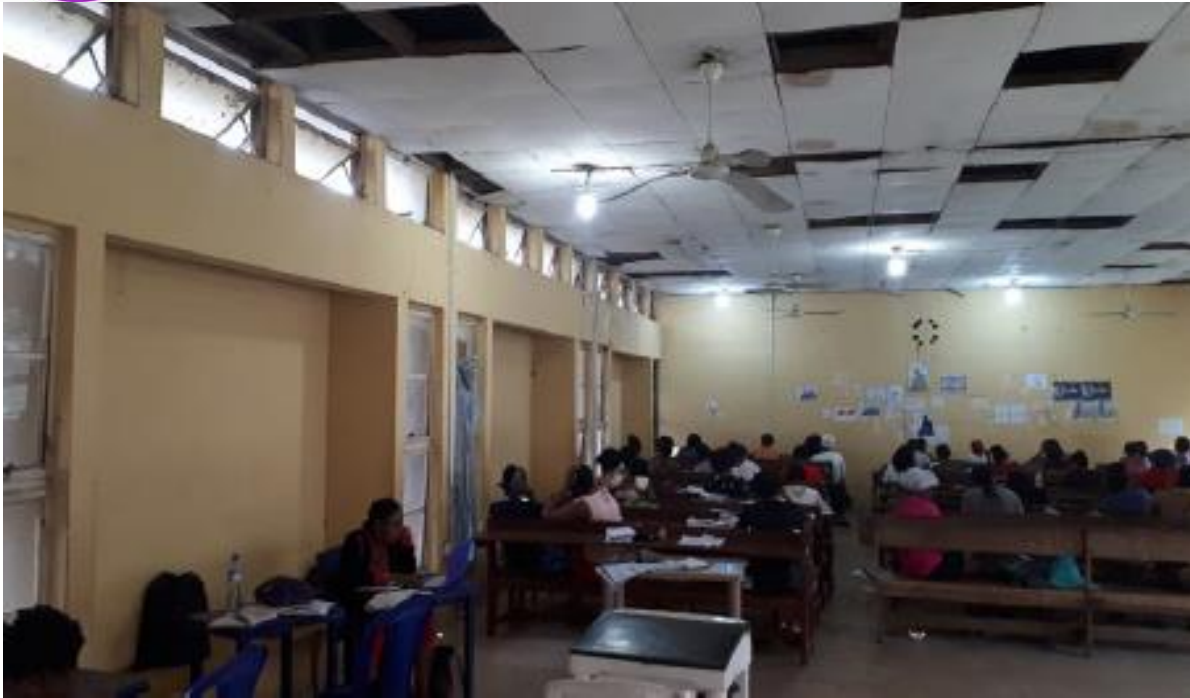
- Walls of the common room were stained and damped
- Papers were littered all over the common room walls
- The electrical wirings were in a bad condition, with very few functional sockets and fans
- The roofs of the common rooms were leaking
- Windows and doors were damaged

Plate 1: Hall 1 Big Reading Room before Repair (1)

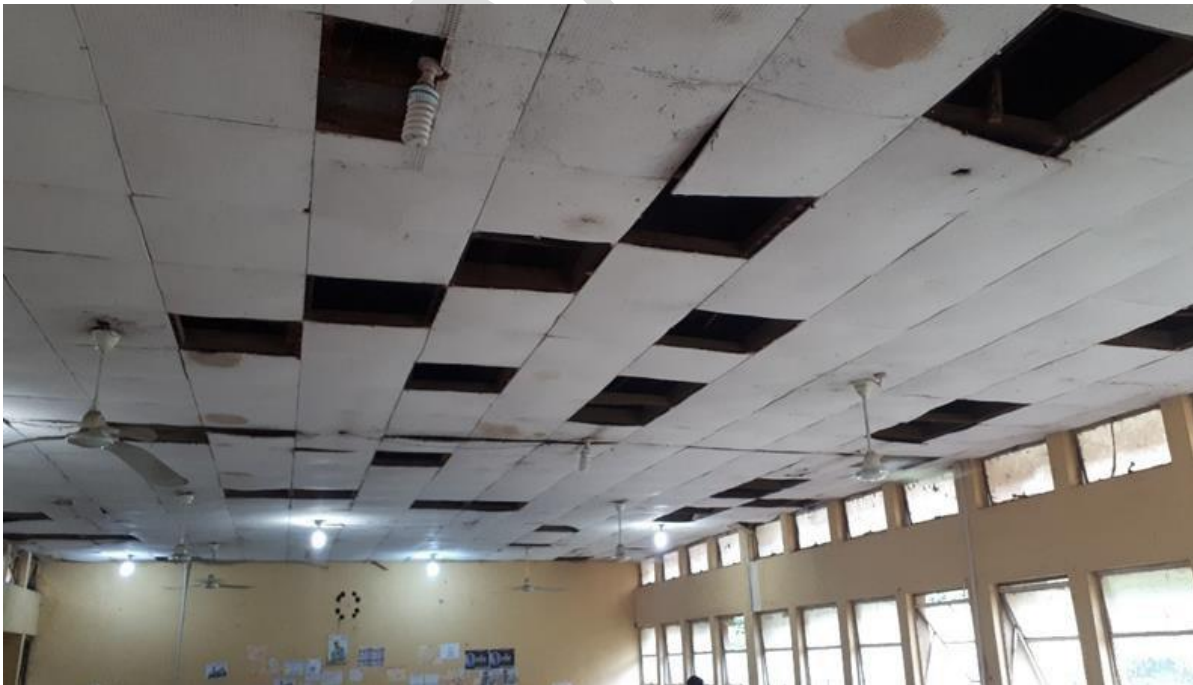
Plate 2: Hall 1 Big Reading Room before Repair (2)

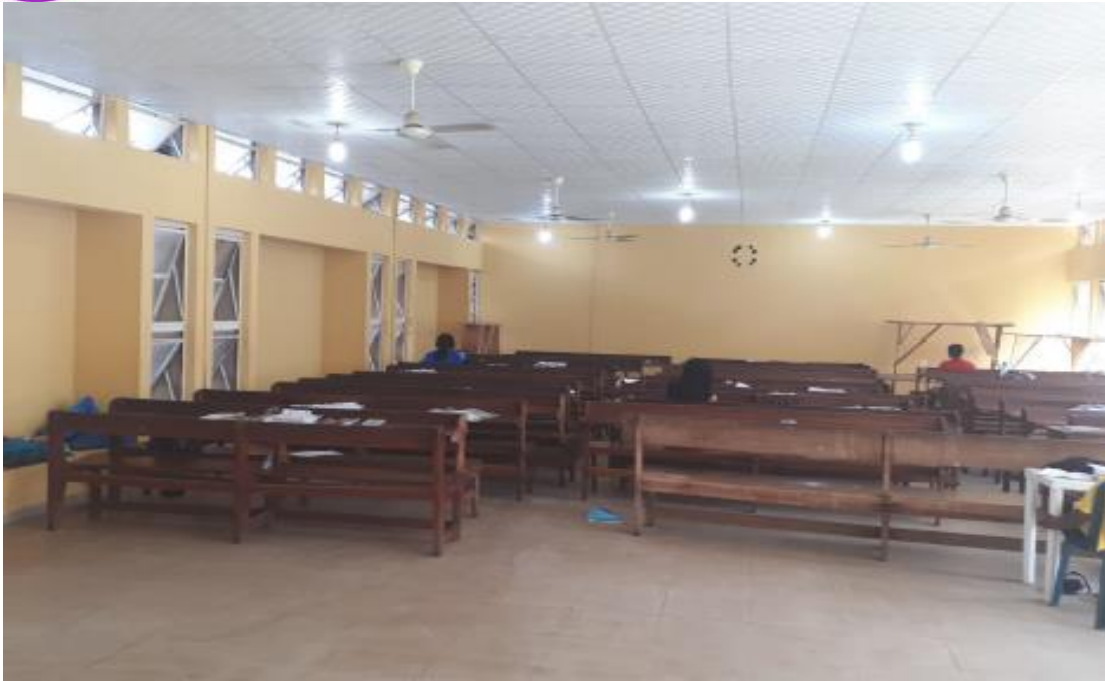
Plate 3: Hall 1 Big Reading Room after Repair (1)

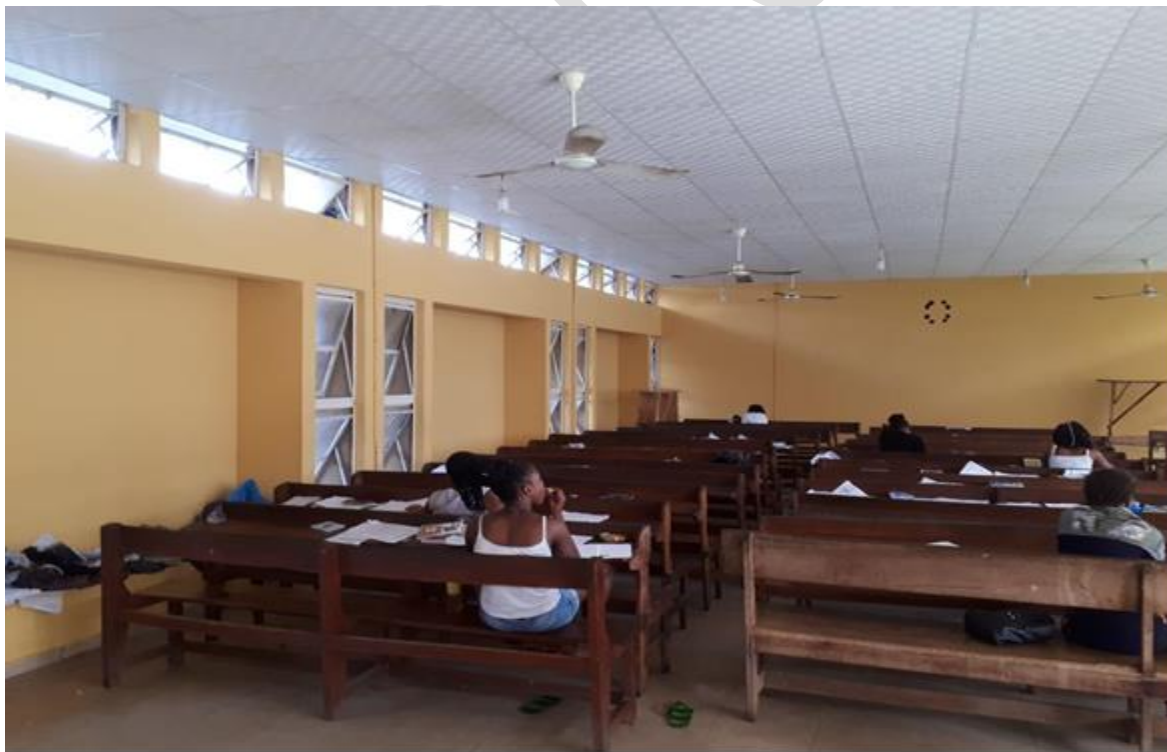
Plate 4: Hall 1 Big Reading Room after Repair (2)

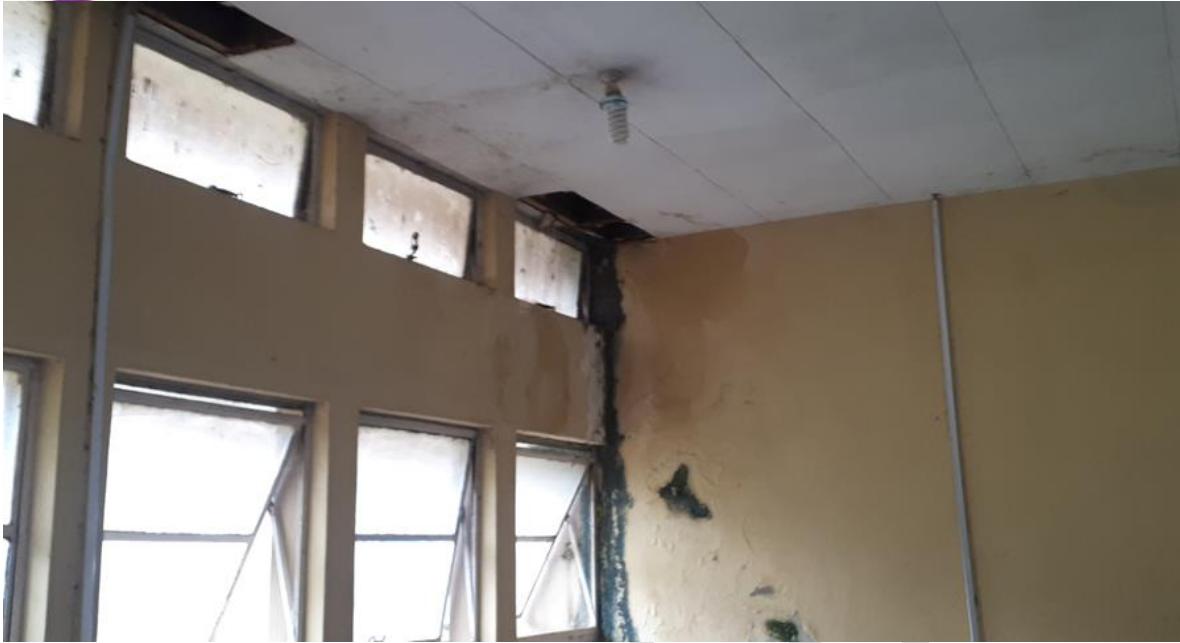
Plate 5: Hall 1 Small Reading Room before Repair (1) - Notice dampness as a result of leaking roof

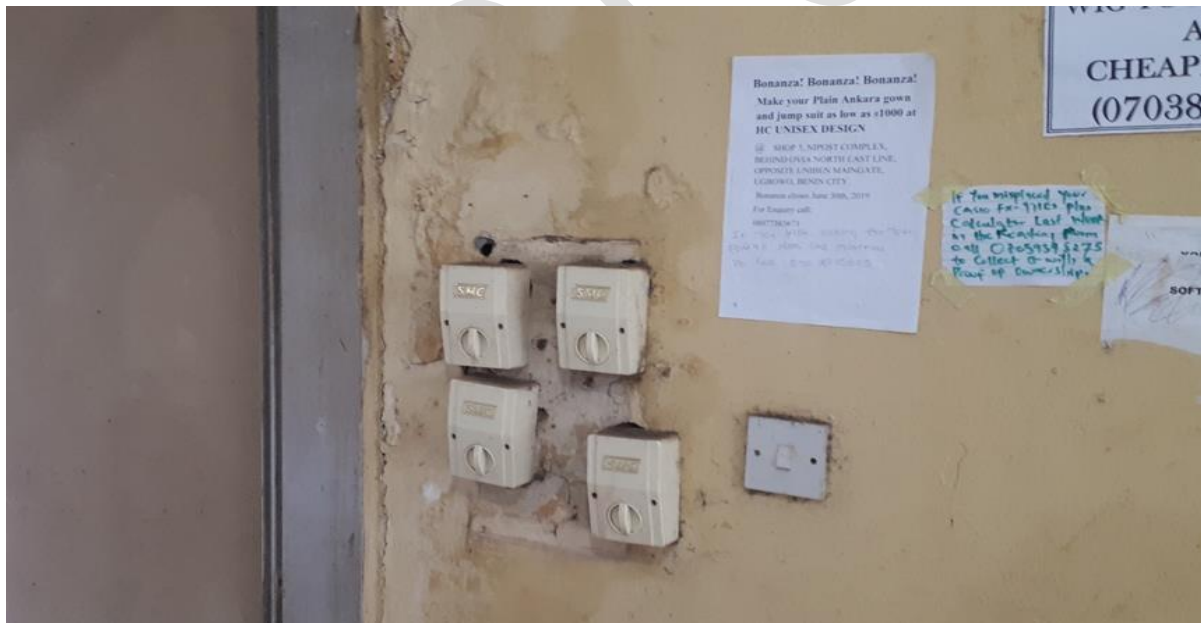
Plate 6: Hall 1 Small Reading Room before Repair (2) – Notice dampness as a result of leaking roof

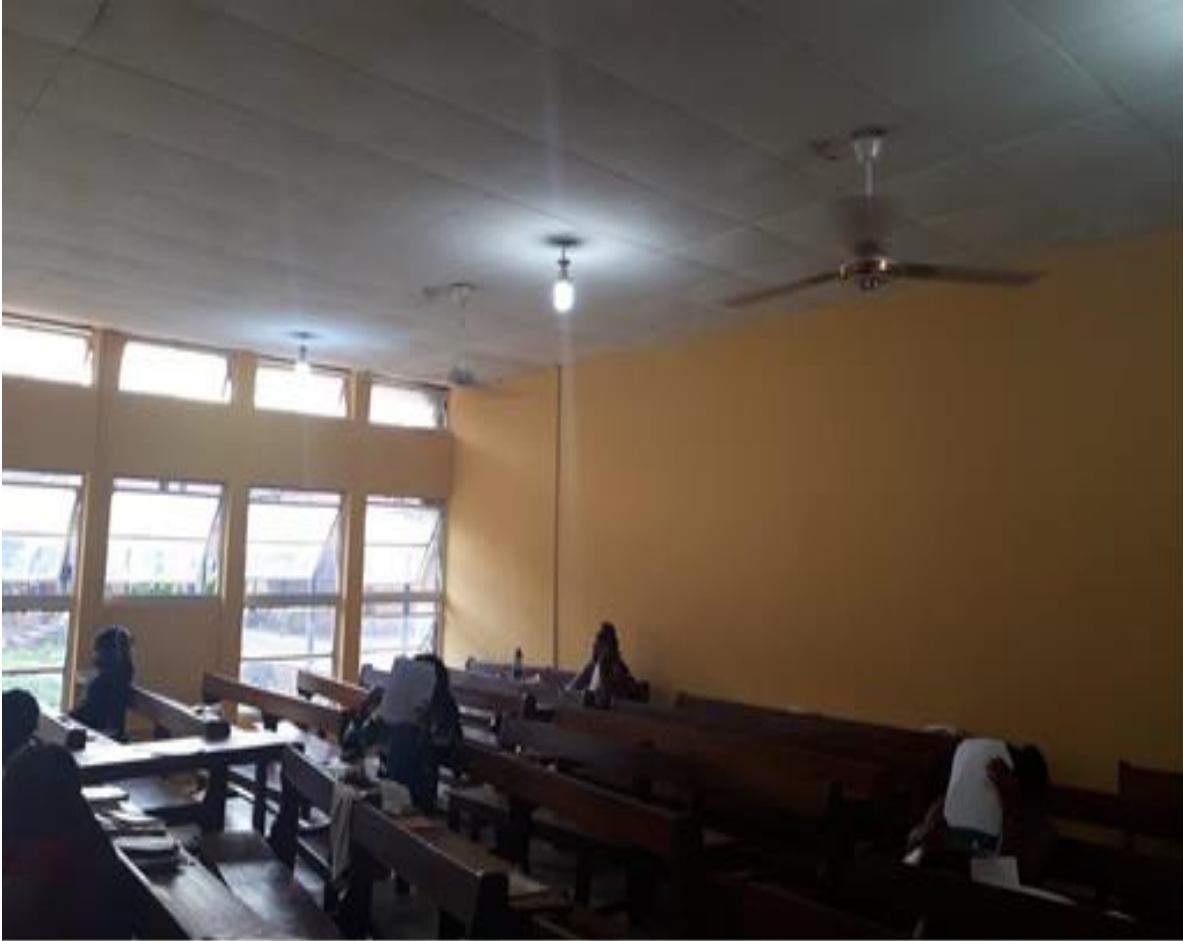
Plate 7: Hall 1 Small Reading Room after Repair

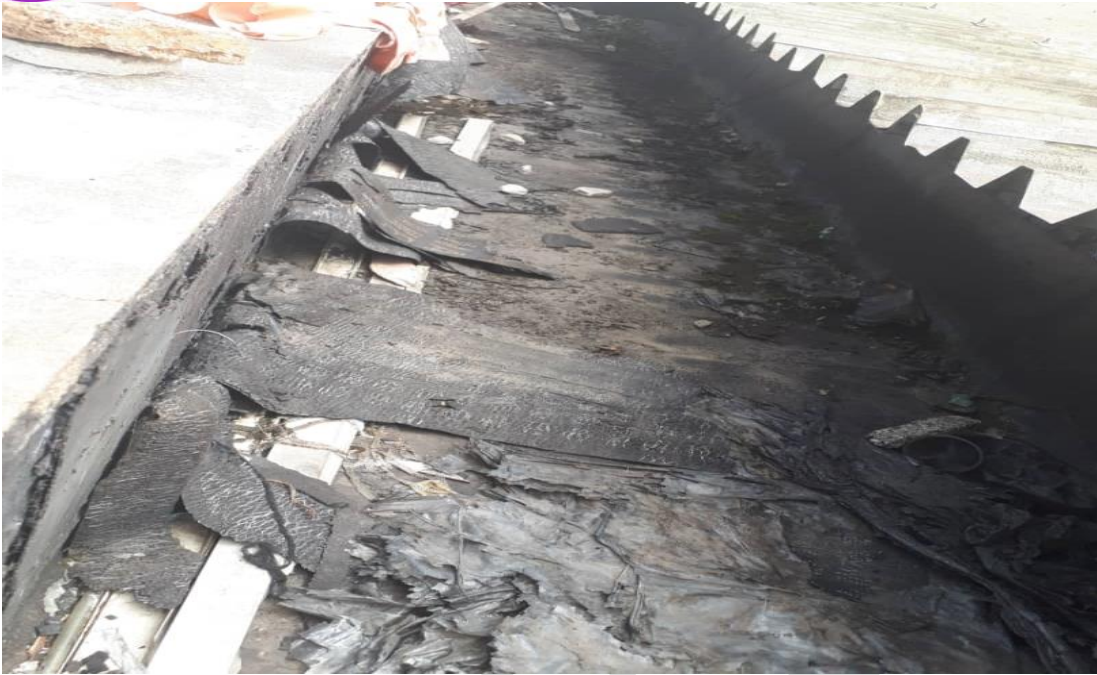
Plate 8: Roof of Hall 1 Reading Room (Failed Bituminous felt) – this makes the roof to leak

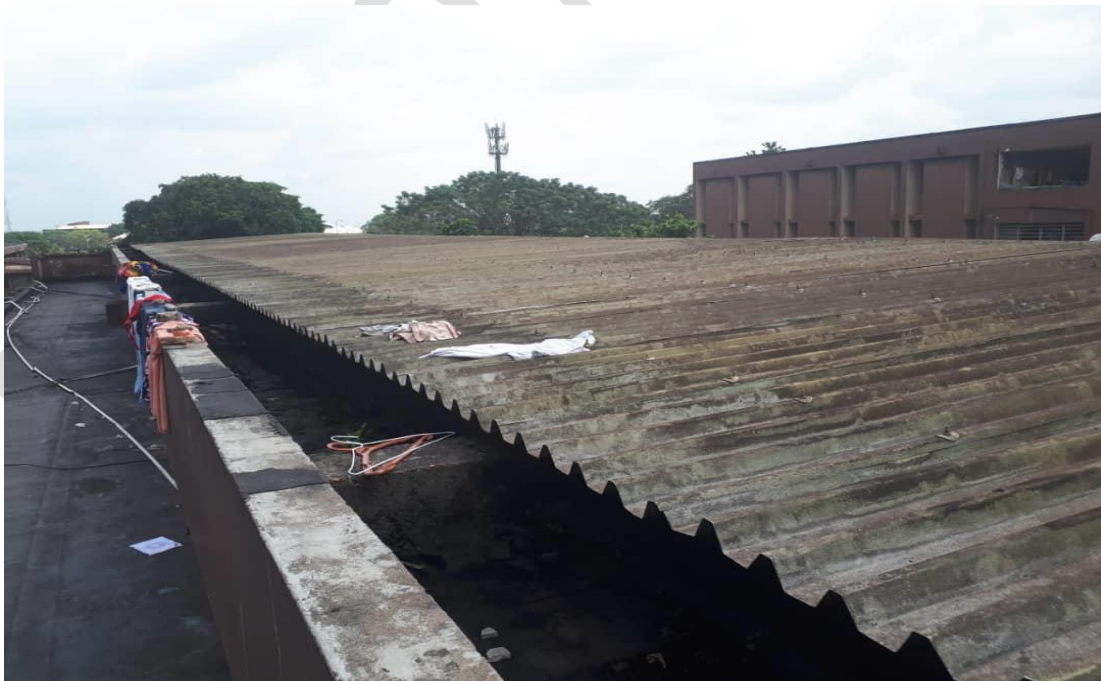
Plate 9: Top view of Hall 1 Reading Room felt

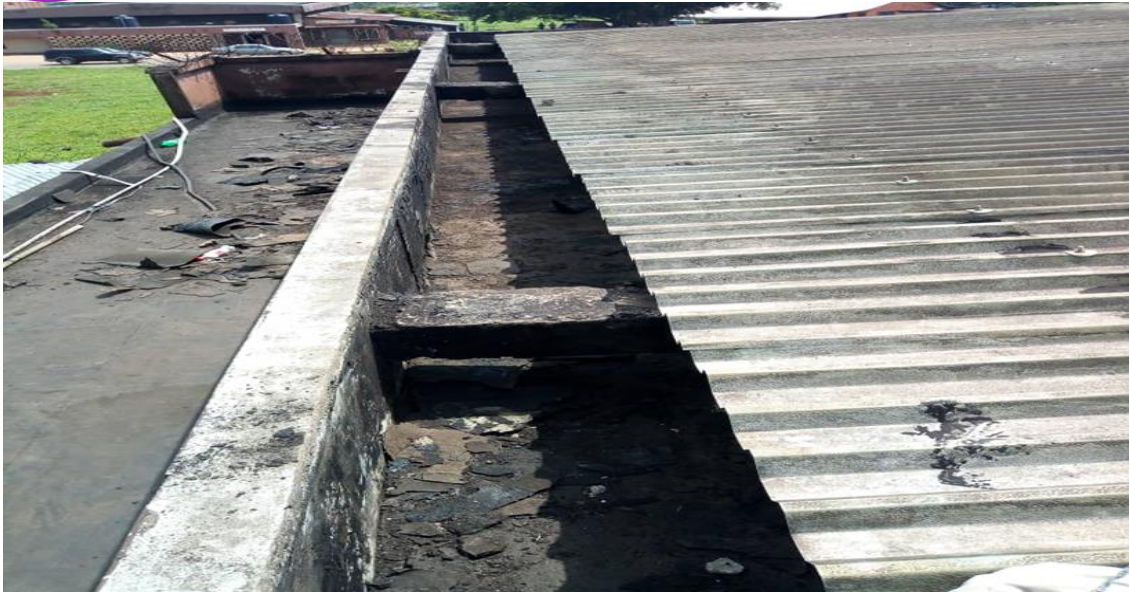
Plate 10: Top view of Hall 1 Reading Room felt

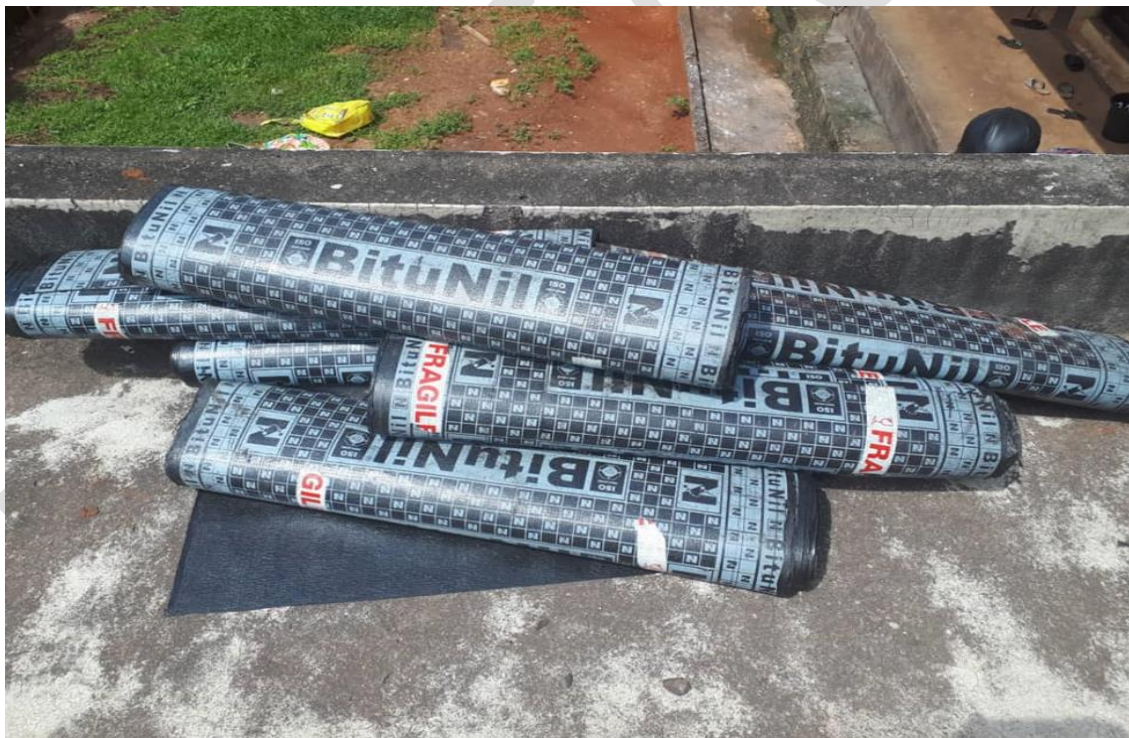
Plate 11: Material for roof felt for repair

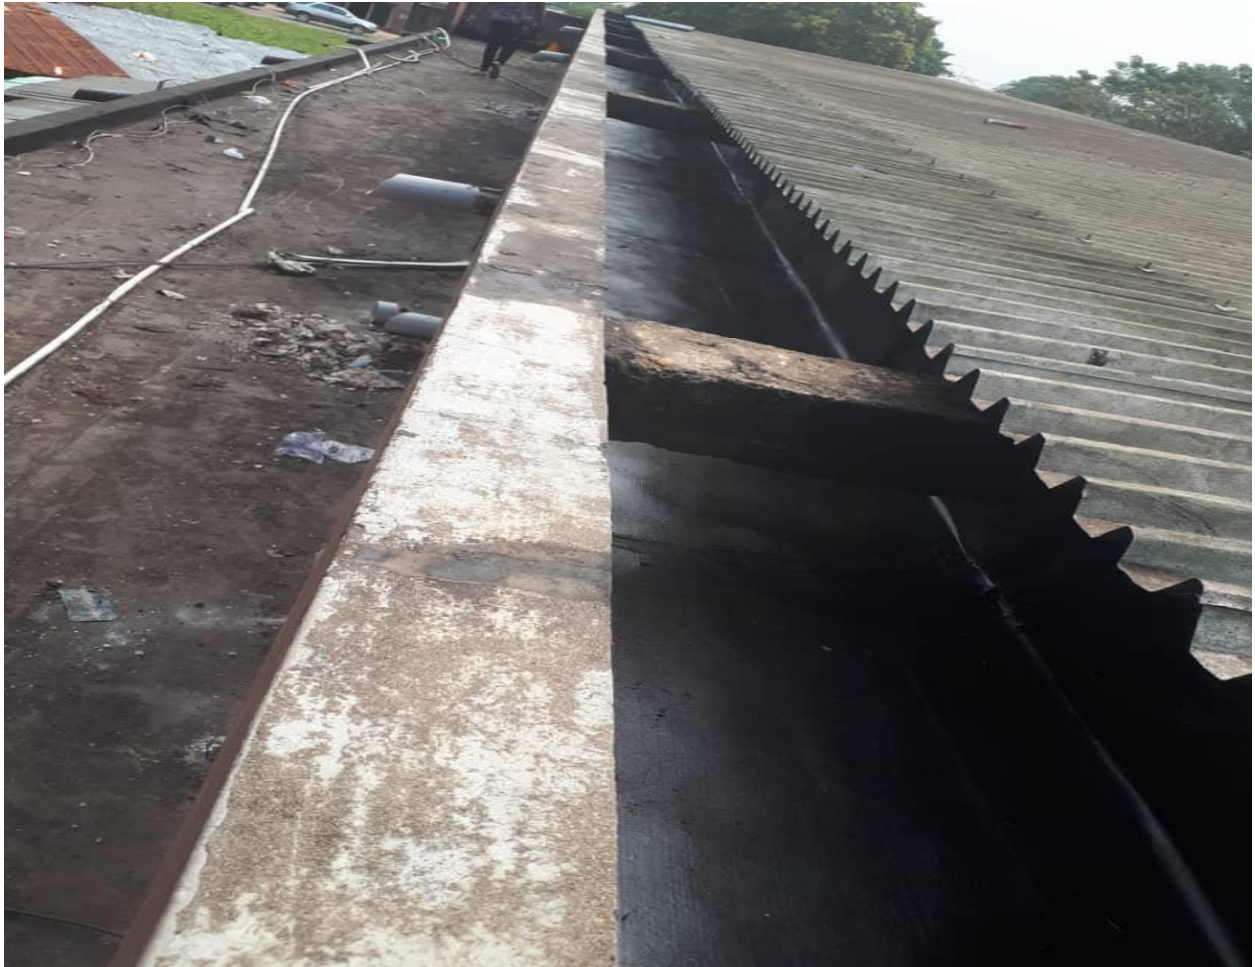
Plate 12: Roof after repair

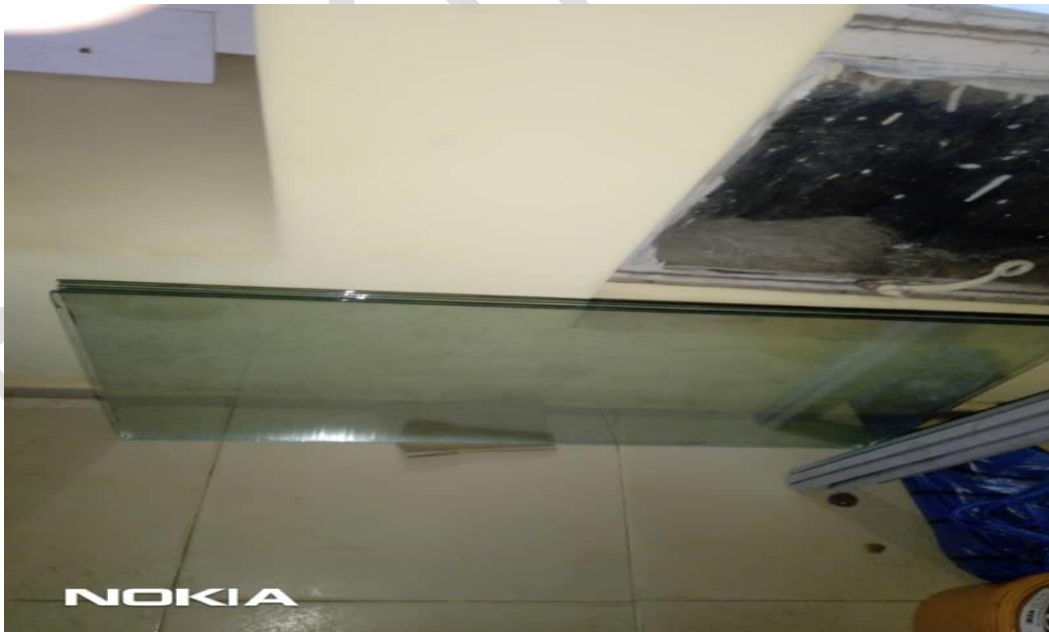
Attachment 6: Procured glasses for window and door repair

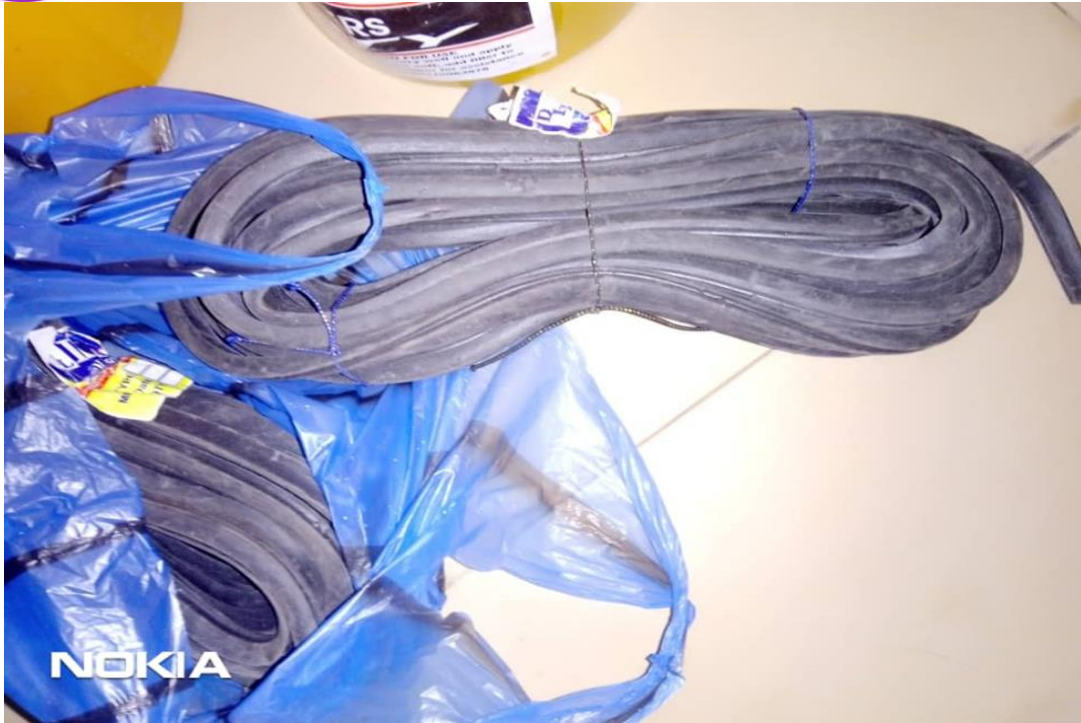
Attachment 7: Door fittings

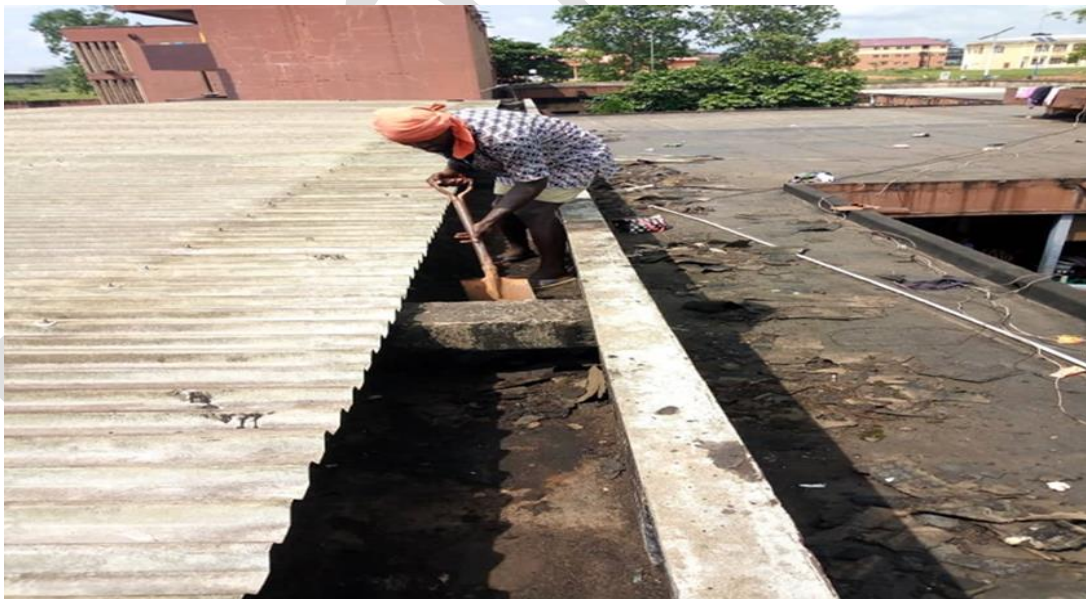
Attachment 8: Clearing of failed bituminous surface of roof

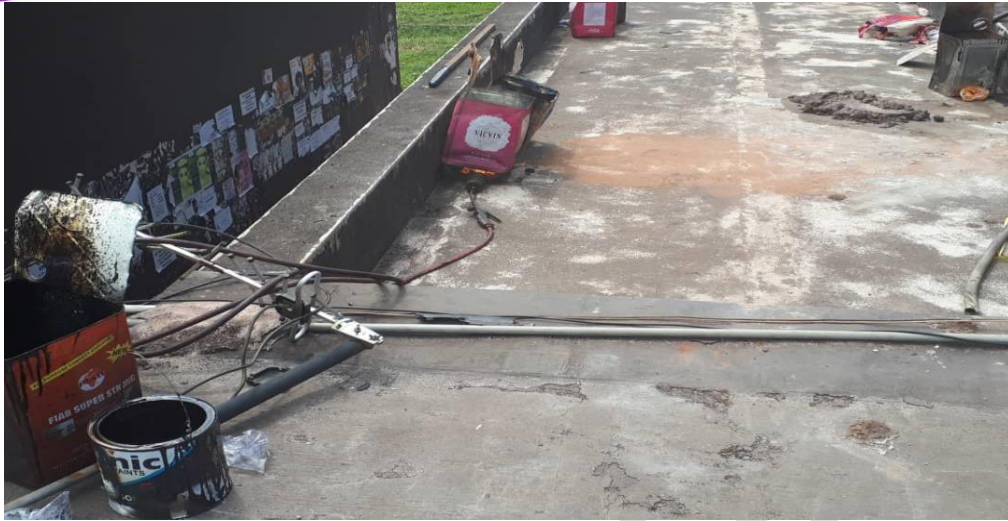
Attachment 9: Heating of bitumen for roof repair

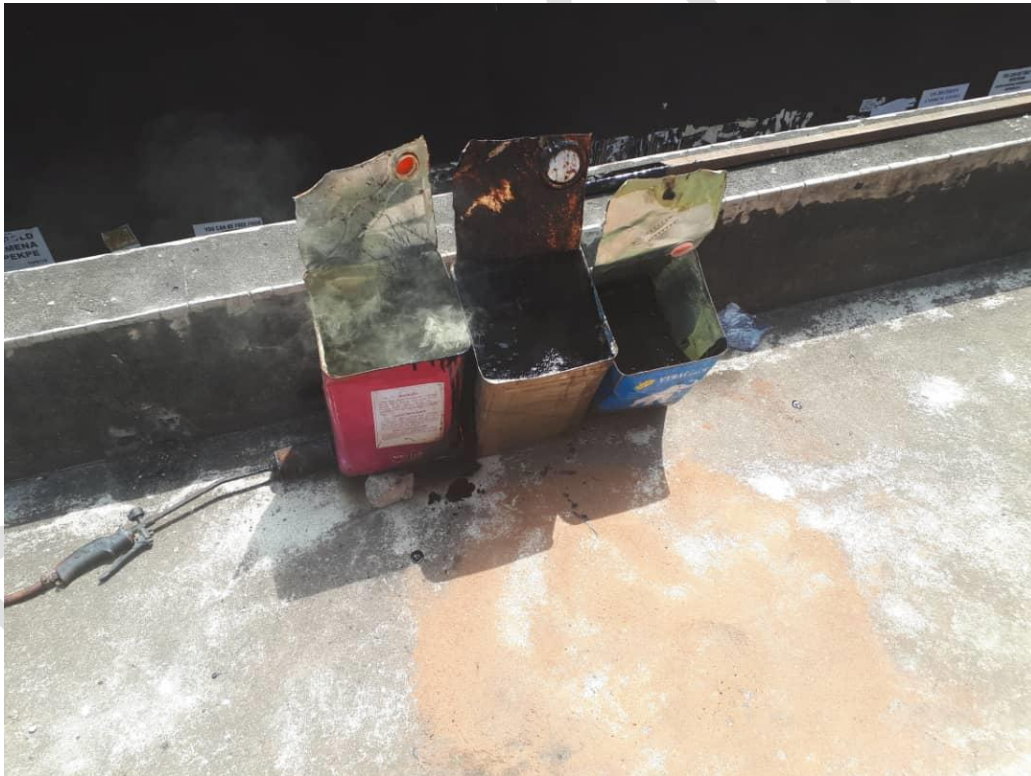
Attachment 10: Heating of bitumen for roof repair (2)

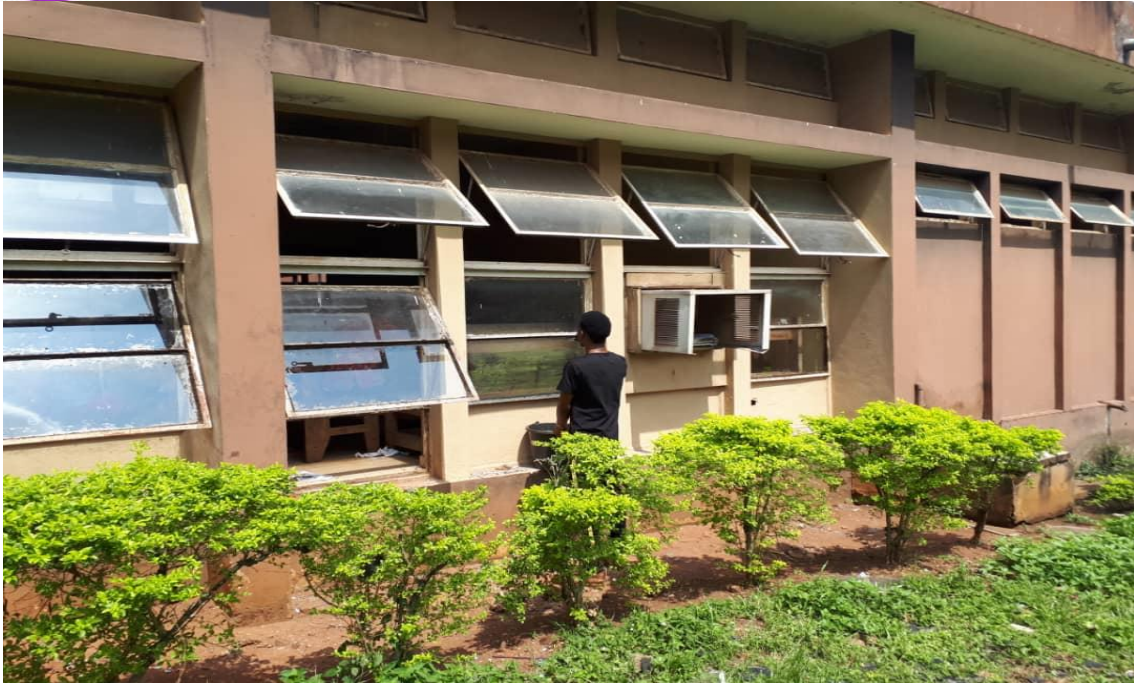
Attachment 11: Repaired windows

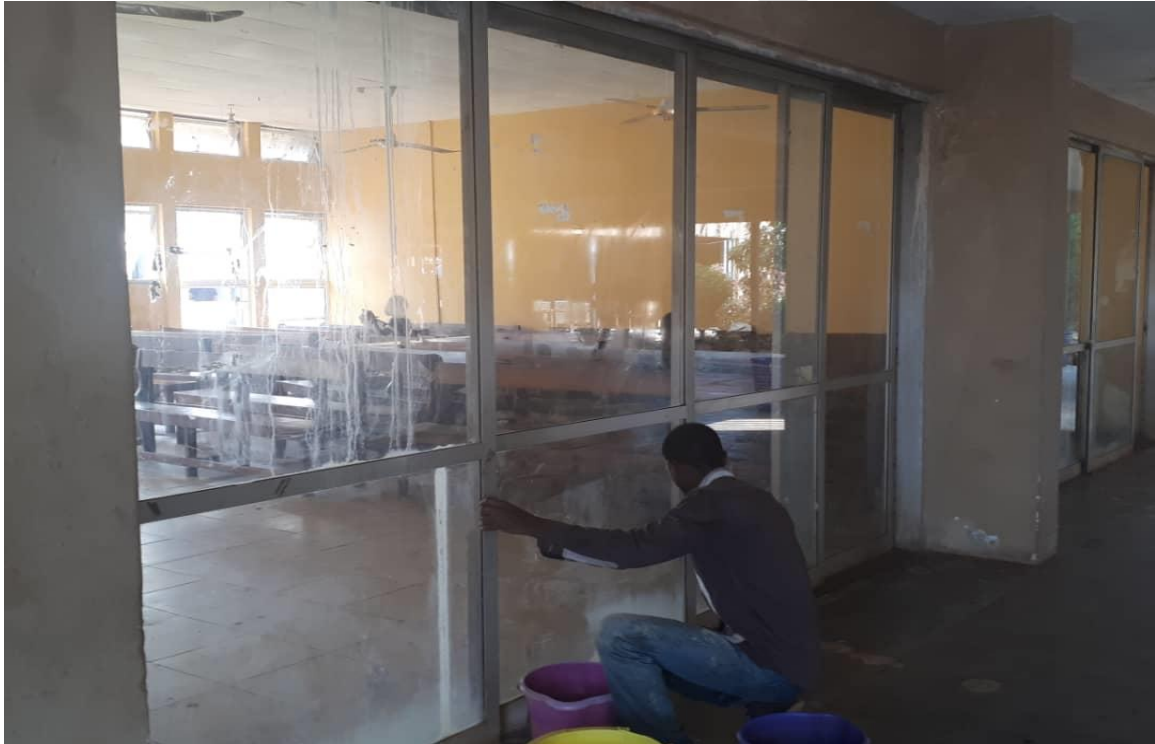
Attachment 12: Cleaning of Reading Room doors (1)

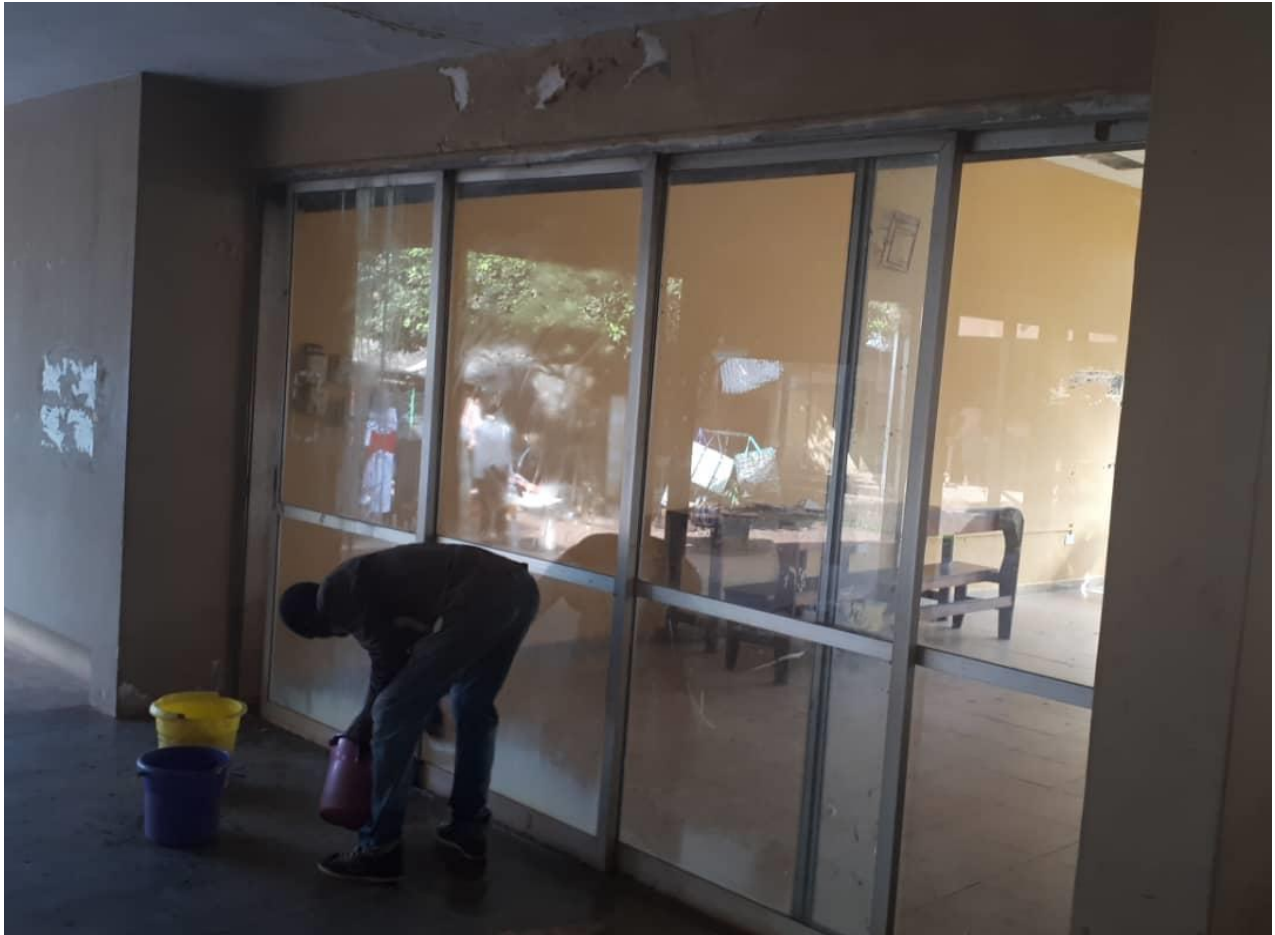
Attachment 13: Cleaning of Reading Room doors (2)
